Case Study: KickAlarm Pump Failure detection

Pump Failure Detection utilizing KickAlarm

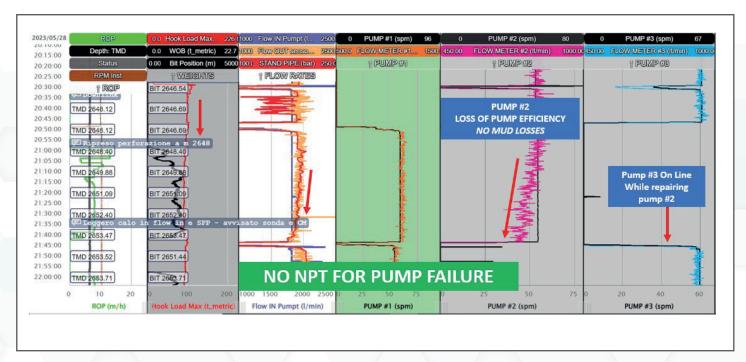
By seeing that pump 2 had a loss of efficiency, was able to swap to Pump 3 and continue Operations whilst the pump 2 was repaired. Saving the client approximately 1 hour or US\$ 50K

Due to the installation of the full set of sensors (3x IN and 1x OUT), the client understanding the anomaly, so excluding other potential challenges related to flow out decrease, Losses, Washout. The reaction is quicker with no NPT due to Pump Failure, as the client could swap to other pumps whilst continuing the operations.
